**PHASE I
ENVIRONMENTAL SITE ASSESSMENT REPORT**

GASOLINE STATION
FORMER WEST HAMLET GROCERY
500 KING STREET
HAMLET, NORTH CAROLINA 28345

FEBRUARY 15, 2007

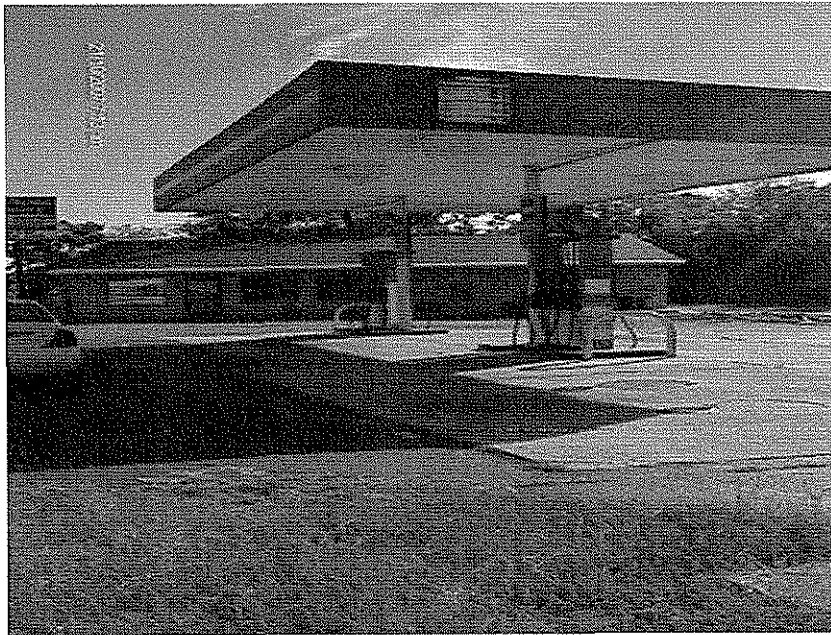
Photo 1 - View looking southeast at the subject property.

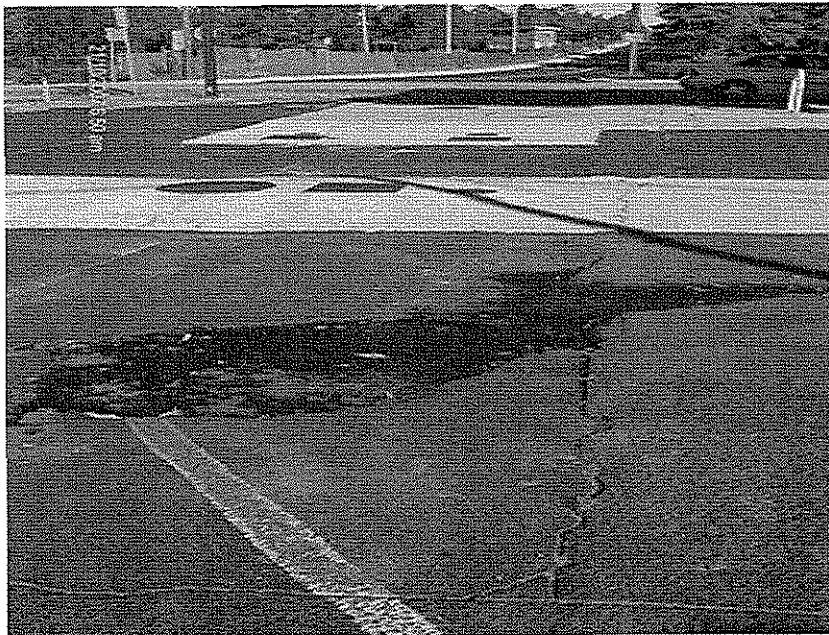
One kerosene AST and an associated dispenser were observed adjacent to the northwestern portion of the subject property building. No evidence of leaks or staining was observed associated with the kerosene AST at the time of the site visit. In addition, the approximate location of USTs was observed on the northwestern portion of the subject property. A dispenser

island was also observed on the northwestern portion of the subject property. According to Annette Parker, Administrative Officer for the UST Section of the NCDENR, the USTs on the subject property were never registered; therefore, no information regarding the capacity, age or installation date of the USTs was available. Based on the lack of available information regarding the USTs on the subject property, this was considered to be a REC.

Photo 2 - View looking at the approximate location of the underground storage tanks (USTs) on the western portion of the subject property.

Based on these findings, AAI recommends that a Limited Phase II Environmental Site Assessment (ESA) be conducted at the subject property. The Limited Phase II ESA should include a geophysical survey across the subject property to confirm the location of the USTs and potential associated subsurface structures. In addition, the Limited Phase II ESA should include soil and groundwater sampling to assess the potential for contamination in the subsurface at the subject property associated with the historical gas station on the subject property.

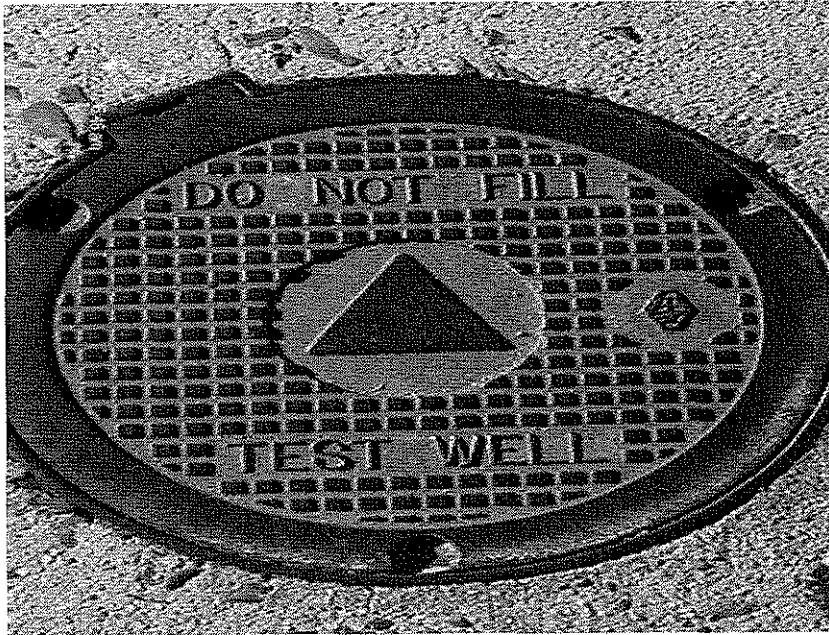
Two groundwater monitoring wells were observed on the subject property. This included one to the east of the fuel dispensers and one to the southwest of the fuel dispenser. However, no data regarding these wells was available.

Photo 5 - View looking at one of two monitoring wells located on the subject property.
